Original Article

Evaluation of Changes in the Surface Topography of Implant after Implantation

N. Devi, K. R. Rameshkumar, P. Arun Kumar, R. Ajay, K. Divya

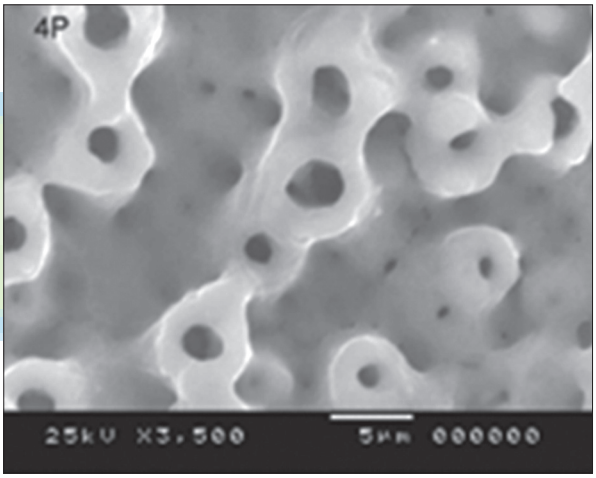
Figure 7 shows the SEM image of TIUN-ITE surface of Brånemark (Nobel Biocare) before implantation. This structure is most similar to that of human cancellous bone.

Figure 7: The scanning electron microscope image of TIUN-ITE surface of Brånemark (Nobel Biocare) before implantation

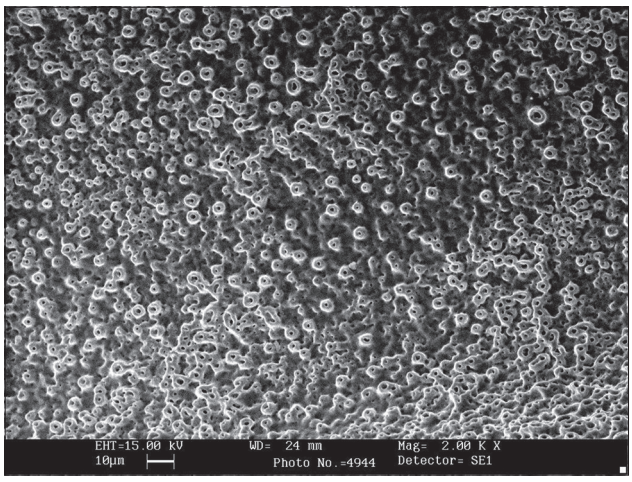
Figure 8 shows the SEM image of TiUnite surface (apical portion of implant) after implantation. Grains on the surface are more closely packed. There was no noticeable difference compared to the surface topography of the implant before implantation.

Figure 8: The scanning electron microscope image of TiUnite surface (apical portion of the implant) after implantation

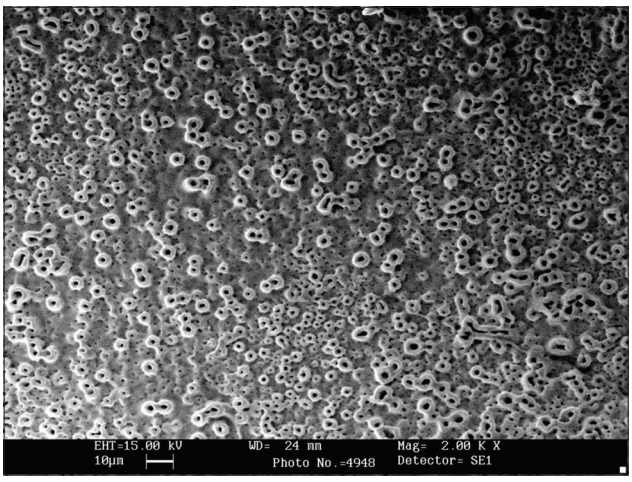
Figure 9 shows the SEM image of TiUnite surface (between the apical and middle portions of the implant) after implantation which shows that grains are slightly dispersed compared to the apical portion.

Figure 9: The scanning electron microscope image of TiUnite surface (between the apical and middle portions of the implant) after implantation

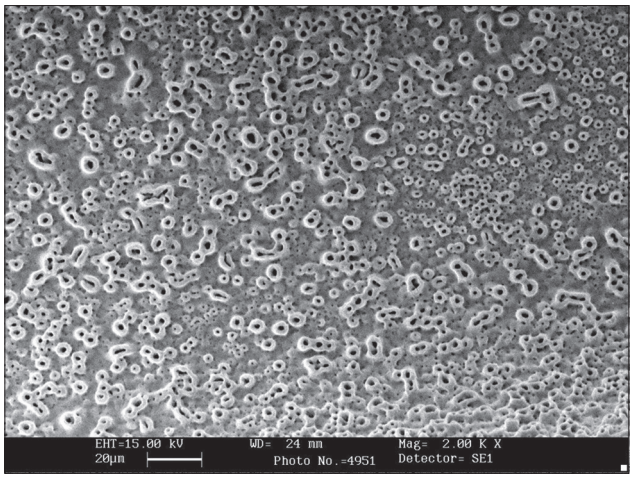
Figure 10 shows the SEM image of TiUnite surface (middle portion of the implant) after implantation. The grains are slightly dispersed compared to those of the apical portion.

Figure 10: The scanning electron microscope image of TiUnite surface (middle portion of the implant) after implantation

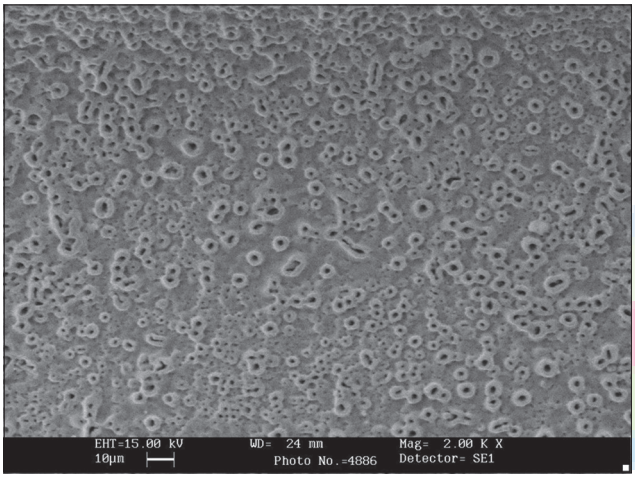
Figure 11 shows the SEM image of TiUnite surface (between the middle and coronal portions of the implant) after implantation. The grains appear more widespread when compared to the areas apical to it.

Figure 11: The scanning electron microscope image of TiUnite surface (between middle and coronal portions of the implant) after implantation

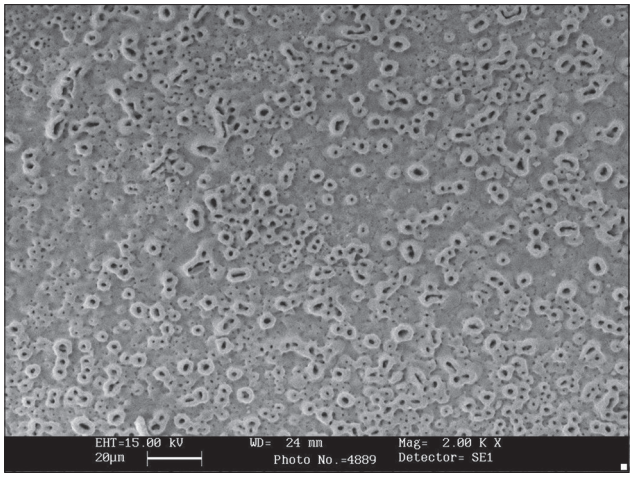
Figure 12 shows the SEM image of TiUnite surface (coronal portion of the implant) after implantation. Grains are more widespread compared to those of apical portion due to contact of the coronal part of the implant to the cortical bone.

Figure 12: The scanning electron microscope image of TiUnite surface (coronal portion of the implant) after implantation

Under SEM, the grains on the surface are more closely packed at the apical end of the implant, whereas toward the coronal portion, the grains are more widespread, indicating that the rough surface present preimplantation on the implant smoothen out during implantation due to the torquing force. The greatest diversion from

the original surface topography is seen in the coronal portion of the implant because the maximum affect of the torquing force used during implant placement is taken up by it. This is because the coronal portion of the dental implant contact with dense cortical bone during insertion torque, and this might affect the surface topography of the implant.
